**Modernes Erbe in Beton**  
**Modern Heritage in Concrete**

**Dokumentation / Documentation**

## 8 Patch repair, the cure for the typical weaknesses of early Modern and older Heritage in concrete

**Guido Stegen, arch.**

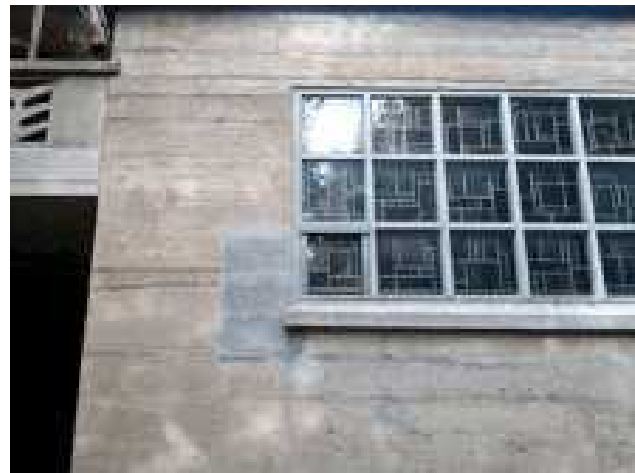
Fig. 2: The patch repair, made using modified mortar, ages differently (more blueish) than the original substrate.

- Repairs do not age like the original material in place; their appearance will differentiate themselves more and more with time (Fig. 2)
- They tend to accelerate the erosion of the original substrate where it is in contact with the repair, which causes the loss of adhesion.

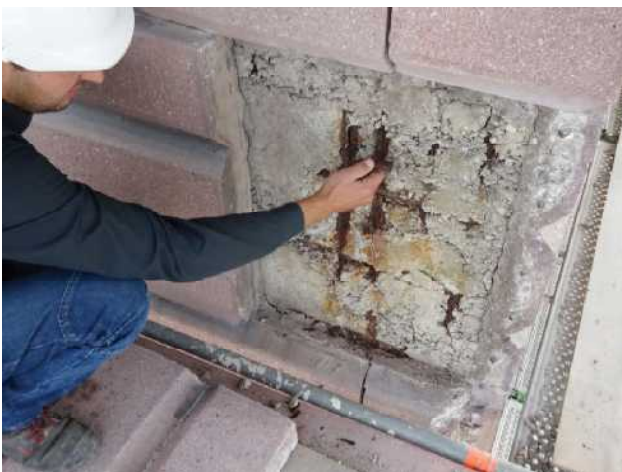
Fig. 3: See 3.1.2: Honeycombs and larger voids in the back of the lost in architectural concrete

the casting joints, between closely spaced rebars, on the surface of the demoulded concrete, or in the back of the lost formworks in natural stone, in architectural concrete, ... etc. (see Fig. 3)

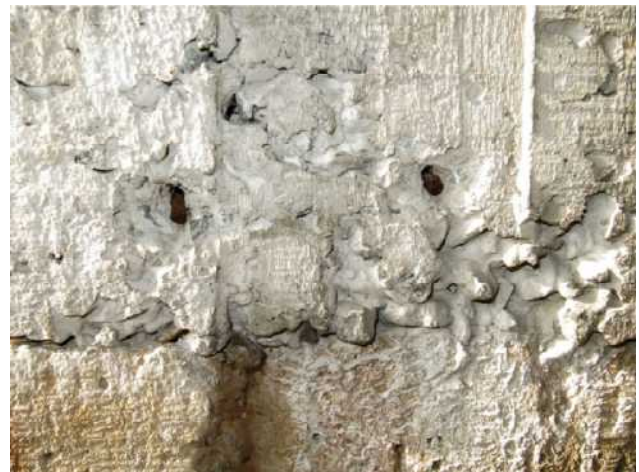
Fig. 4: Honeycombs above the retrieval joint; homogeneous but sparse concrete below the joint. The black dots in the gravel nest are rebars bare for 60 years, without expansive rust, despite their exposure up front

III) Significant differences in the carbonation depth between the zones above and below the pouring joints (see fig.4). A few centimetres below the joint the depth is much greater than above the seal due to the water/cement factor which is higher there<sup>9</sup>. On the other hand, it should be noted that it is not uncommon to find gravel pockets just above the retrieval joint. The casting joint is therefore typically a risk area.

4) Steel surfaces exposed to air and moisture, often remain relatively intact contrary to what might be expected. It is then mainly soft steel, of rounded section. (see Fig. 4)

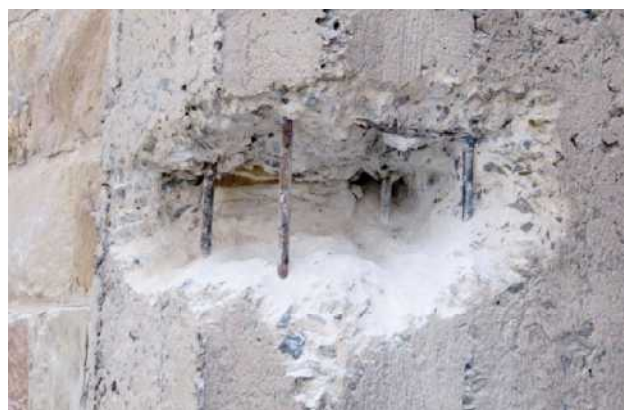
Figure 6: Damage caused to connect all reinforcement, including those located in non-carbonated areas

- By opting for more delicate seeking and connecting techniques for reinforcements (see Fig. 6)
- By reducing the reinforcement to connect to those located in the carbonated or potentially carbonated concrete. (See Fig. 5 and 6).

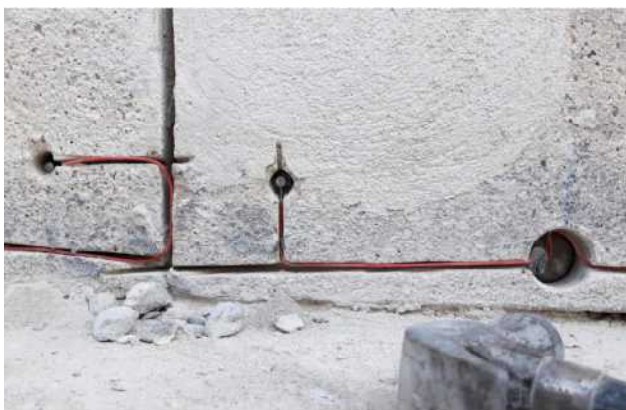
Fig. 7: To limit the damage by finer techniques of search and connection of reinforcement, limited to those located in the carbonated or potentially carbonated concrete.

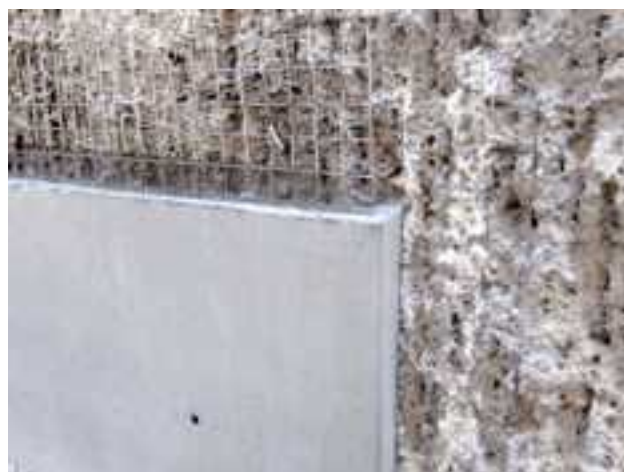
Fig. 8. Layer of concrete.

le to sink without honeycombs or voids or to empty a layer of concrete 4 to 6 cm thick, of complex and irregular shape (Fig. 8) and which has to be simultaneously resistant to carbonation (and therefore without plasticizers<sup>16</sup>, nor excess of water).

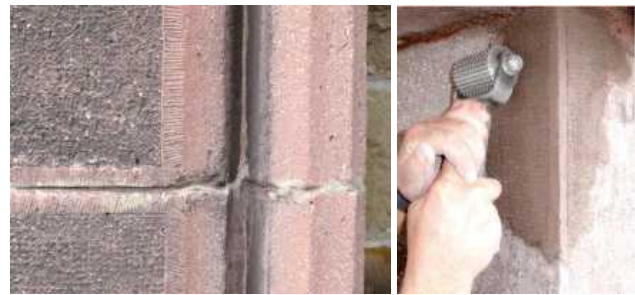
Fig. 9 and 10: On the left, the relief and the original stain on Art Deco architectonic concrete (1927). On the right, restoration of the relief in a fresh local repair with tools developed ad hoc.

A custom-made mix, regular inspections and adjustments allow the use of appropriate mortars depending on the location and the specific context of the repairs. For an implementation on small surfaces, the local realization of the original relief, must often be done with other techniques than those used during the creation of the monument. In-depth research can reveal whether the epidermis originally benefited from a finish (wood stain, whitewash, paint, sandblasting, etc.). The restoration of this finish has the advantage of softening any color differences in patch repairs compared to the original skin. (Fig.11)

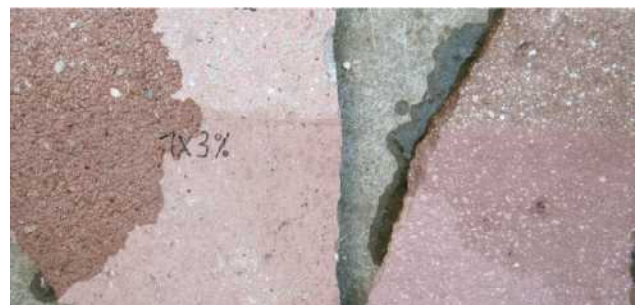
Fig. 11: Staining and Porometry Modification Treatment Tests
